# Recreational Use Attainability Analysis for White Oak Creek (0303B) in the Sulphur River Basin

Prepared for:  
Texas State Soil and Water Conservation Board  
Project 16-60

Texas Institute for Applied Environmental Research  
Tarleton State University  
Stephenville, Texas

TR1708

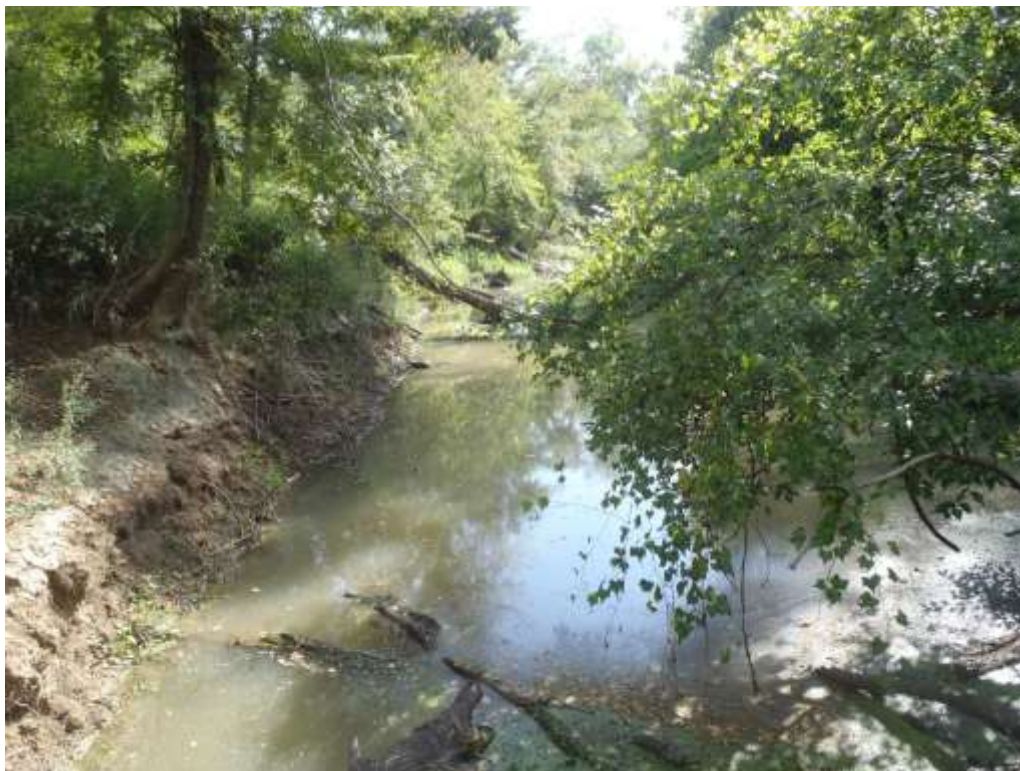
**Figure 4.72** Photograph of White Oak Creek Site WH32 taken on August 9, 2016. Upstream view of the 150-m transect.

White Oak Creek at Site WH32 was visited on July 21 and August 7, 2016. This site was accessed via a locked private property gate, approximately 1 mile from the public road. Access was granted by the landowner to enter the property leading to White Oak Creek Sites WH32, WH33, and WH34. The large riparian area was densely forested on both the left and right banks and continued up to the stream bank (Table 4.5). Banks at this site were incredibly steep, slippery, and poison ivy was abundant. These factors made stream access difficult. Additionally, this site contained a large amount of tree debris and large logjams (Figures 4.71 and 4.72) during both surveys making walking through the channel difficult.

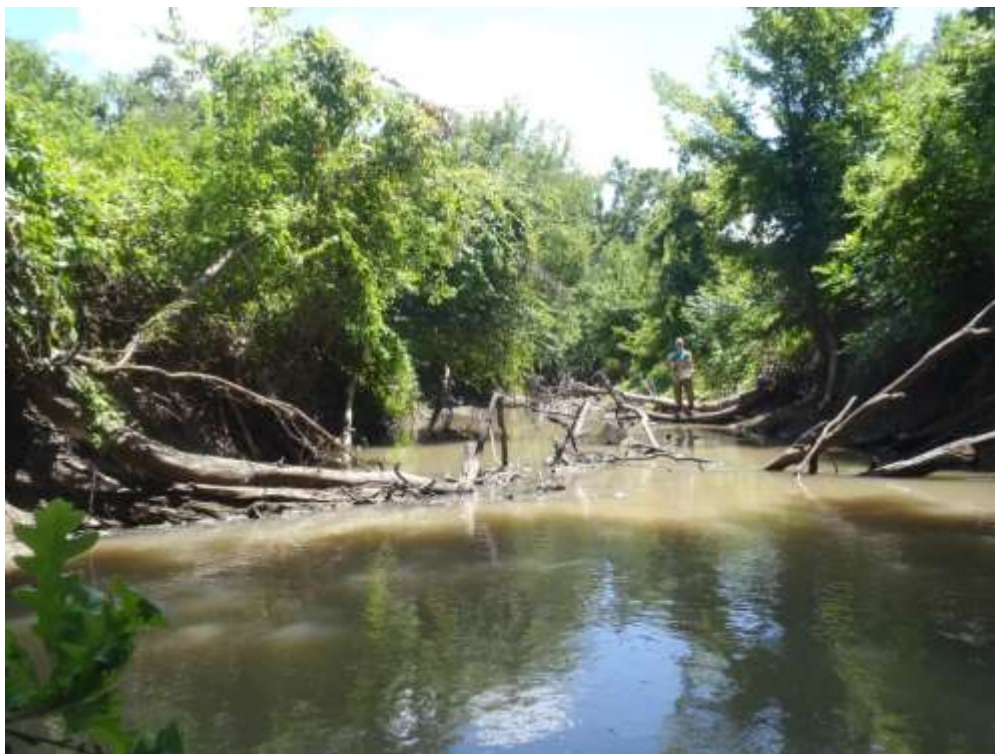
**Figure 4.73** Photograph of White Oak Creek Site WH33 taken on July 21, 2016. Downstream view of the 300-m transect. TIAER personnel in photo.

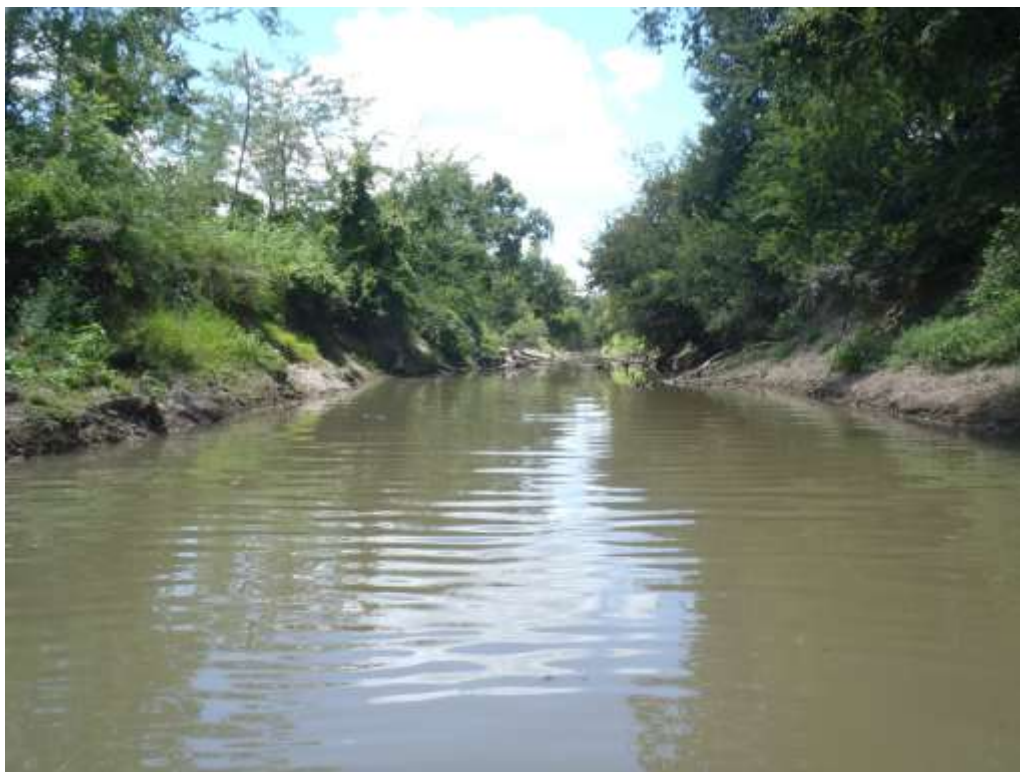
**Figure 4.75** Photograph of White Oak Creek Site WH34 taken on July 21, 2016. Upstream view of the 300-m transect.

White Oak Creek at site WH34 was visited on July 21 and August 7, 2016. This site was located on private property behind a locked gate. TIAER personnel accessed this site with landowner permission via a Polaris Ranger. The large riparian area was native forest with dense vegetation on the left bank and improved pasture on the right bank (Table 4.5). Access was difficult as stream banks leading to the channel were steep and slippery on both the left and right banks. Figures 4.75 and 4.76 depict the appearance of the site during each of the surveys.

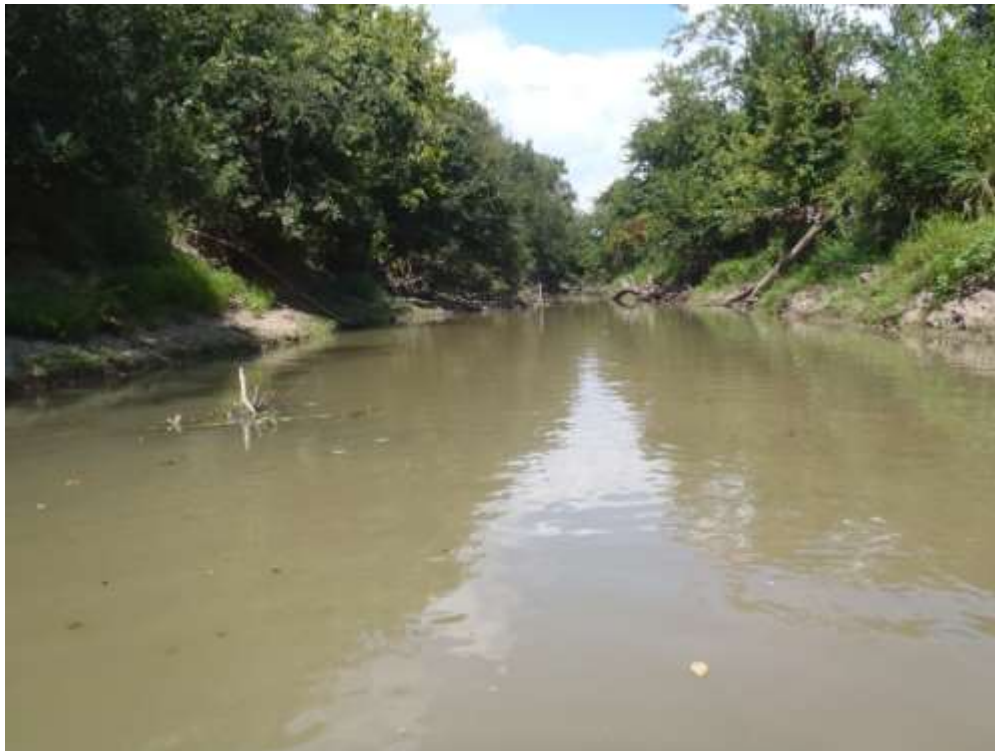
**Figure 4.76** Photograph of White Oak Creek Site WH34 taken on August 9, 2016. Downstream view of the 0-m transect.

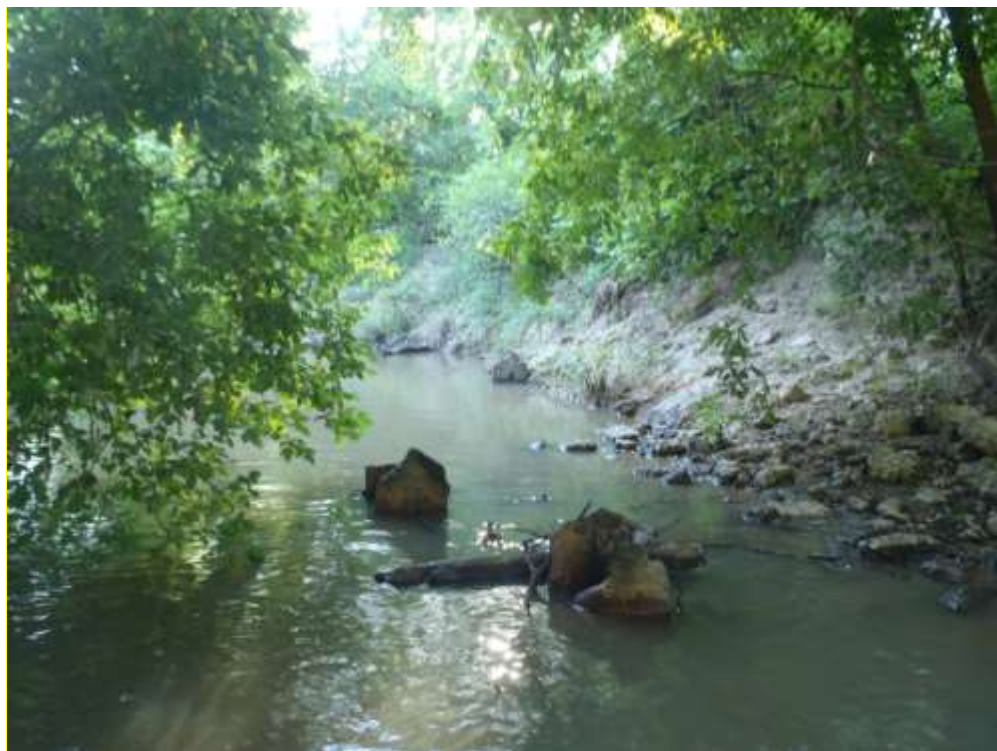
**Figure 4.77** Photograph of White Oak Creek Site WH35 taken on July 22, 2016. Upstream view of the 150-m transect.

White Oak Creek at site WH35 was visited on July 22 and August 7, 2016. This site was located where FM 69 intersects with White Oak Creek in Hopkins County. The portion of FM 69 near this site appeared to receive a large volume of traffic moving at a fast rate of speed. This site was publically accessible at the road crossing. TIAER personnel entered the stream at this road crossing and completed the survey up and downstream. The riparian area was large with thick, native forest vegetation extending into the banks at this site. Stream banks were steep and slick with overgrown, dense vegetation making access to the stream moderately difficult (Table 4.5). Figures 4.77 and 4.78 illustrate the general appearance of this site during each of the surveys.

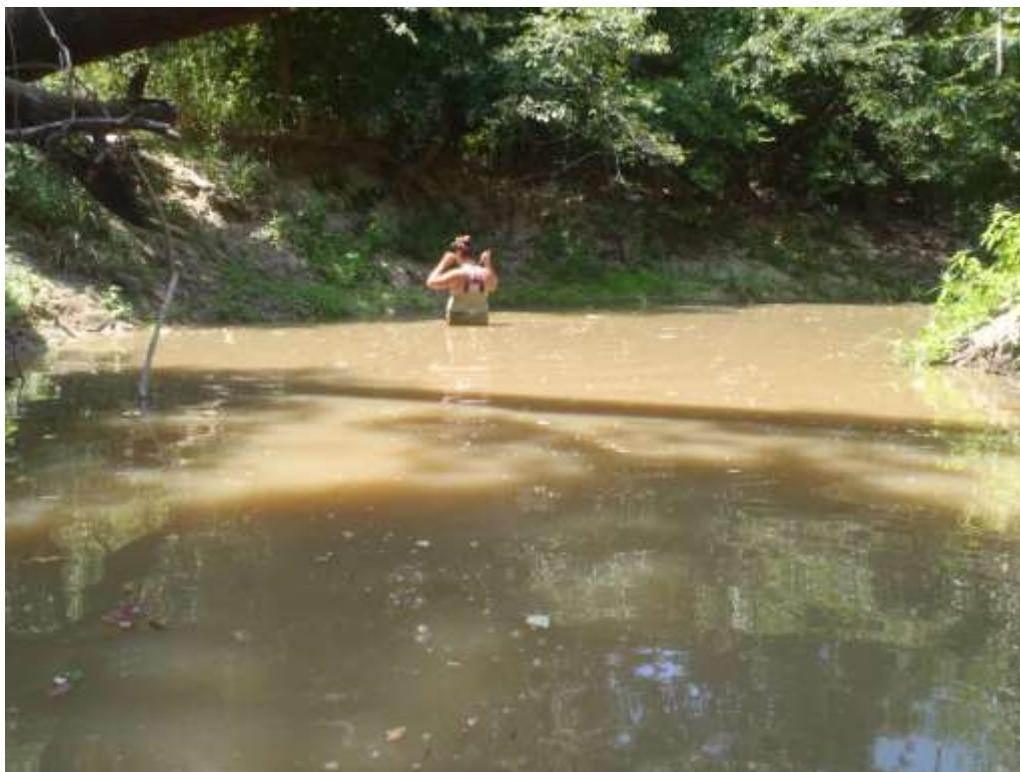
**Figure 4.78** Photograph of White Oak Creek Site WH35 taken on August 7, 2016. Upstream view of the 0-m transect. TIAER personnel in photo.

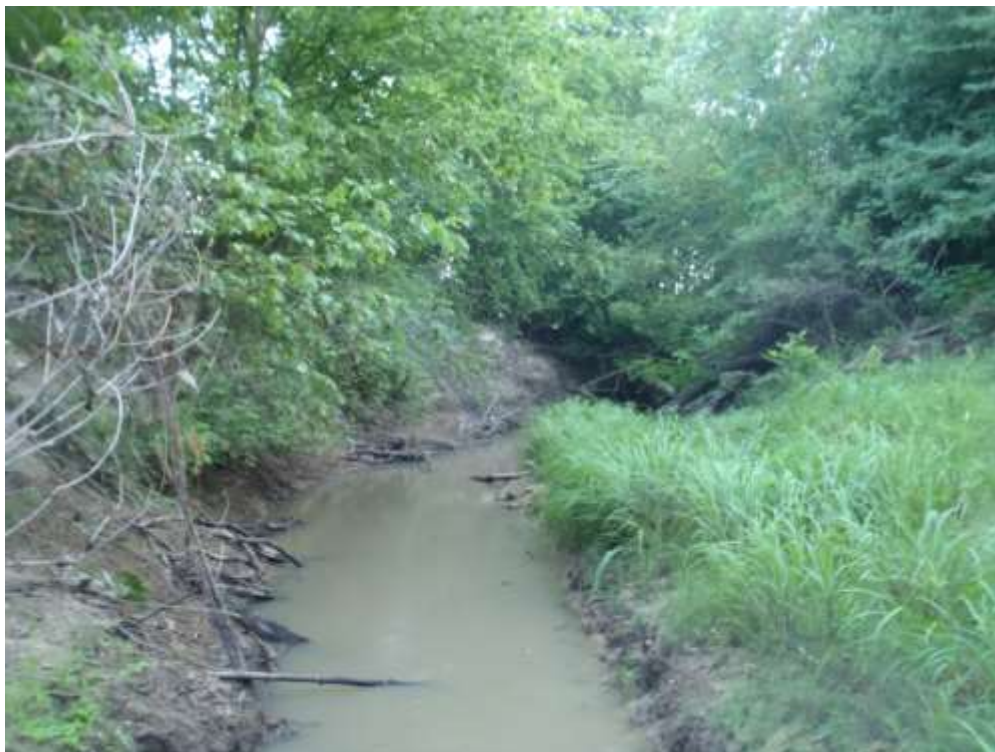
**Figure 4.79** Photograph of White Oak Creek Site WH36 taken on July 21, 2016. Downstream view of the 300-m transect.

Site WH36 on White Oak Creek was surveyed on July 21 and August 8, 2016. This site was located on private property approximately 0.30 miles downstream of CR 3504 in Hopkins County. Permission was granted by the landowner to access the property leading to this site. TIAER personnel traveled via truck through a locked gate and continued through pastureland about 0.5 miles to reach the stream. The riparian area associated with WH36 was large with forest like vegetation and bounded the stream channel with steep banks (Table 4.5). The general appearance of the creek at this location is shown in Figures 4.79 and 4.80.

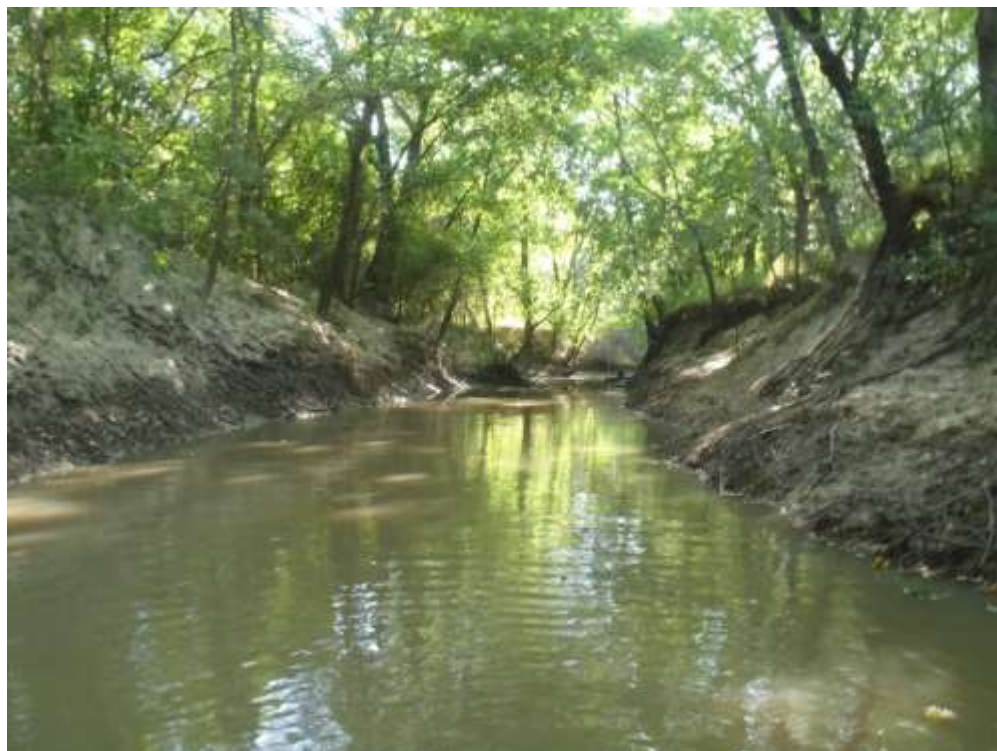
**Figure 4.80** Photograph of White Oak Creek Site WH36 taken on August 8, 2016. Downstream view of the 0-m transect.

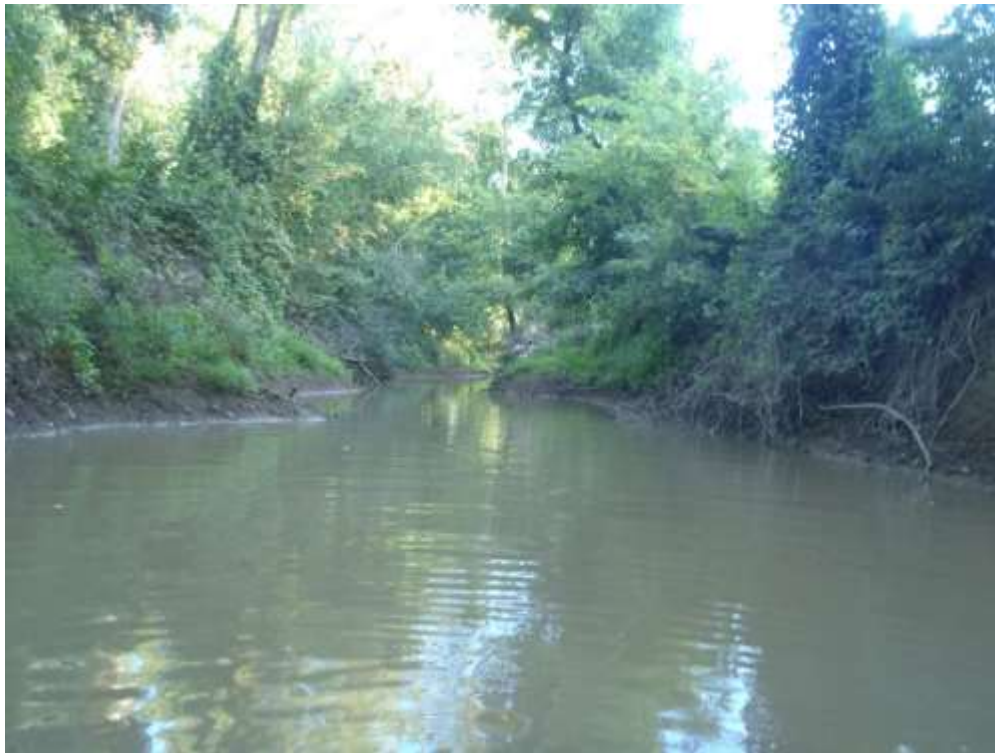
**Figure 4.81**      **Photograph of White Oak Creek Site WH37 taken on July 21, 2016. Upstream view of the 150-m transect.**

At this site, White Oak Creek passes through improved pastures with native vegetation. The riparian area was large with trees and varied between pasture land and forest type vegetation leading up to the edge of the stream bank. The general appearance at this location is shown in Figures 4.81 and 4.82.

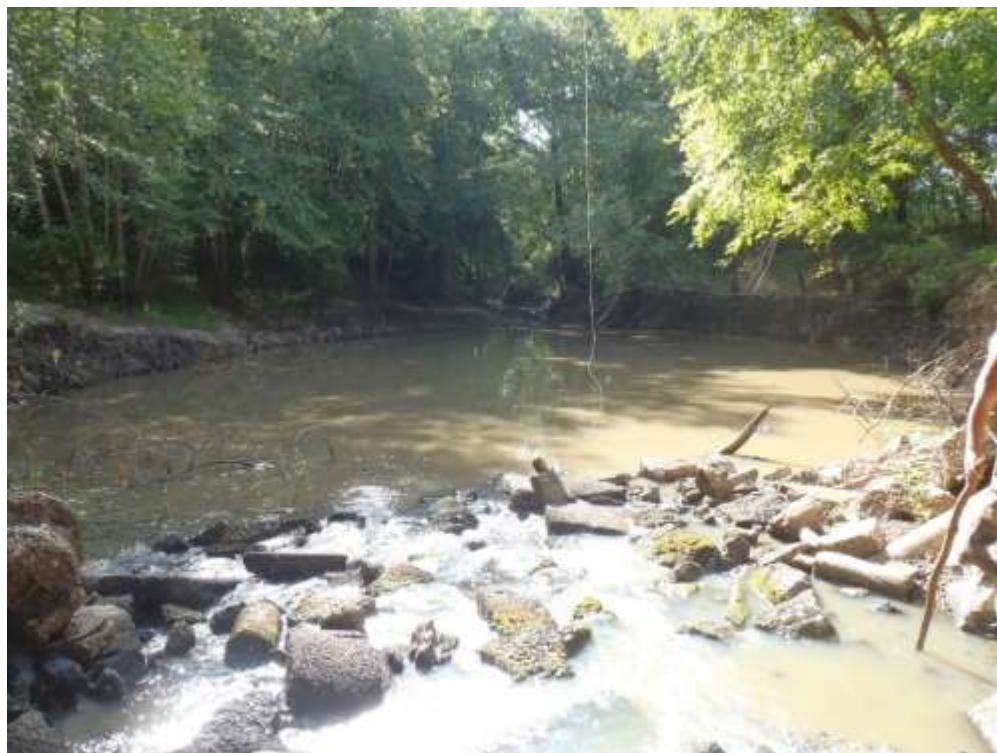
**Figure 4.82** Photograph of White Oak Creek Site WH37 taken on August 8, 2016. Downstream view of the 150-m transect. TIAER personnel in photo.

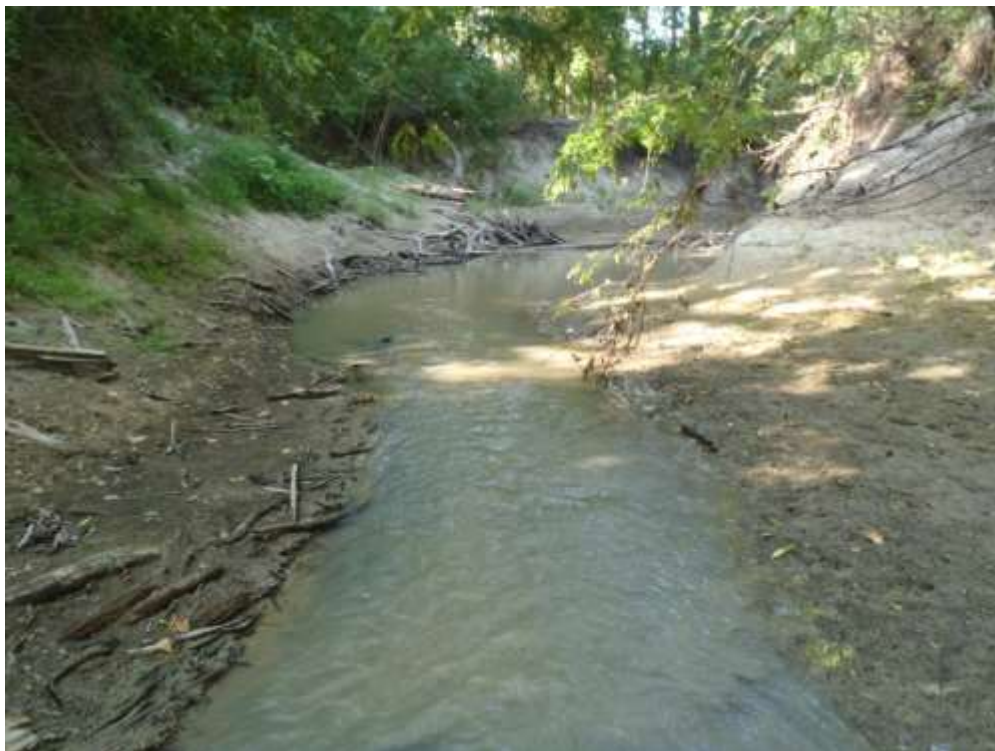
**Figure 4.83** Photograph of White Oak Creek Site WH38 taken on July 22, 2016. Downstream view of the 0-m transect.

White Oak Creek RUAA site WH38 was surveyed on July 22 and August 8, 2016. This site was located on private property approximately 2.2 miles upstream of CR 3504 in Hopkins County. Access to this site was granted by the landowner to the property leading to White Oak Creek. TIAER personnel traveled via truck through a locked gate and continued through pastureland about two miles to reach the stream. The riparian area associated with WH38 is large and immediately bounded on both banks by forest (Table 4.5). The general appearance of the creek at this location is shown in Figures 4.83 and 4.84.

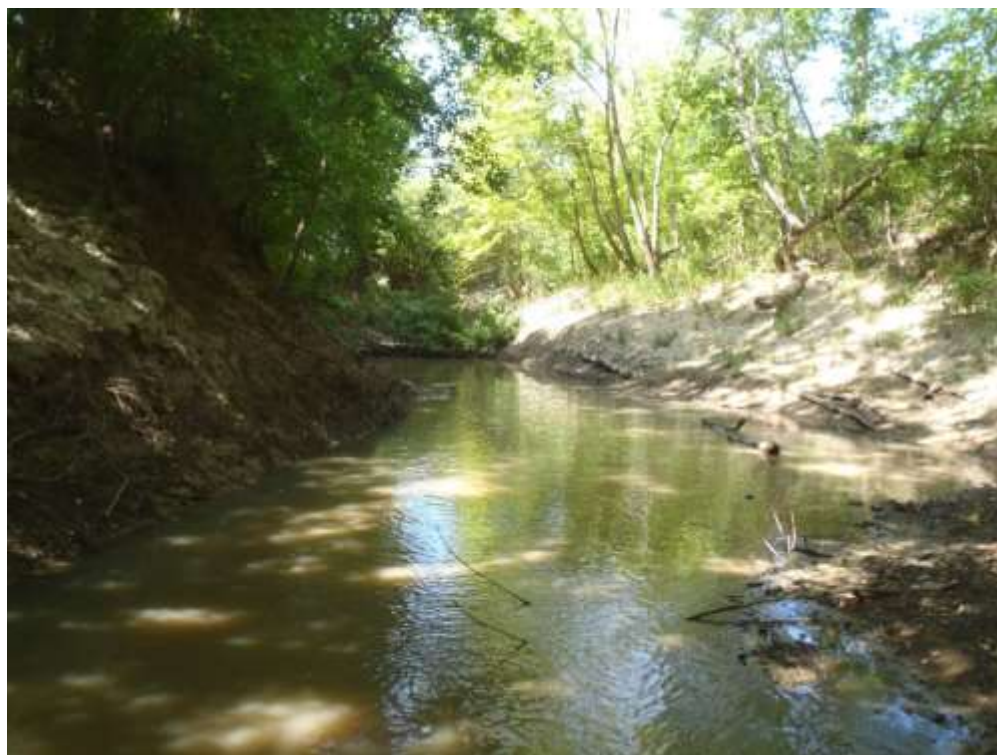
**Figure 4.84** Photograph of White Oak Creek Site WH38 taken on August 8, 2016. Upstream view of the 150-m transect.

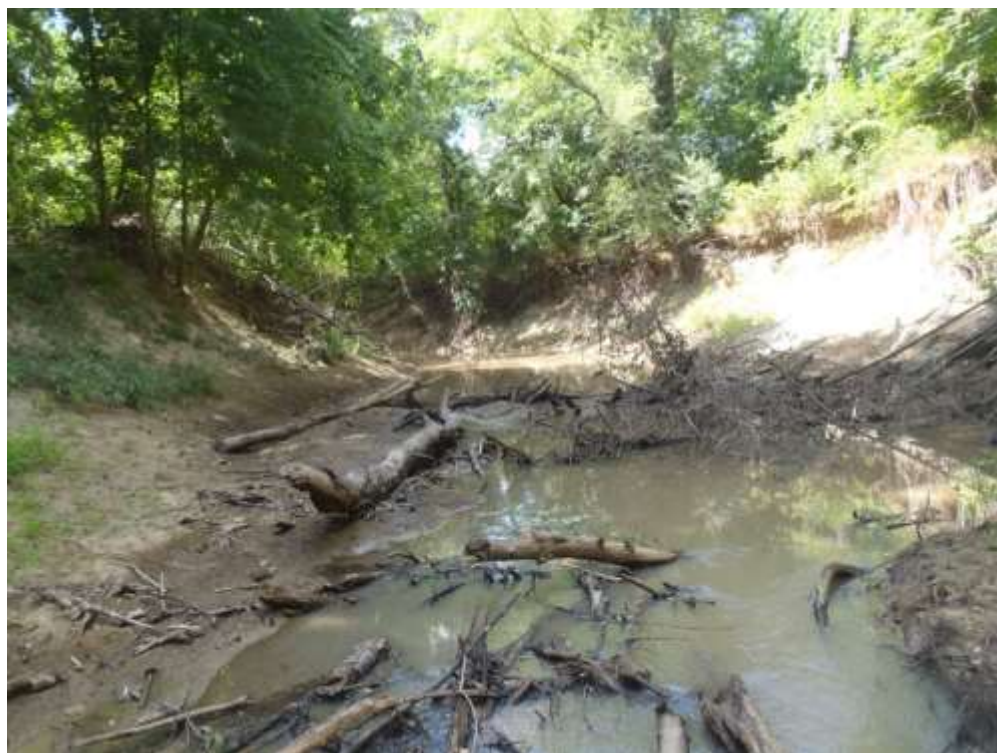
**Figure 4.85**      **Photograph of White Oak Creek Site WH39 taken on July 21, 2016. Upstream view of the 0-m transect.**

The riparian area along the creek at this site was large with trees and native forest leading directly up to the stream bank (Table 4.5). Banks were steep and tall making it difficult for TIAER personnel to walk along the edge of the water. Logjams, low hanging trees, and debris prevented use of a boat. The sludge (“sinking mud”) in the stream channel made this site unsuitable to wade. The general appearance of the creek at this location is shown in Figures 4.85 and 4.86.

The stream flow at this site was designated as intermittent. Figure 4.85 illustrates the typical width of the creek at this site, approximately 8 m. Widths ranged from 4 m to 10 m in the first survey and 2.5 m to 10 m during the second survey (Tables 4.7 and 4.8).

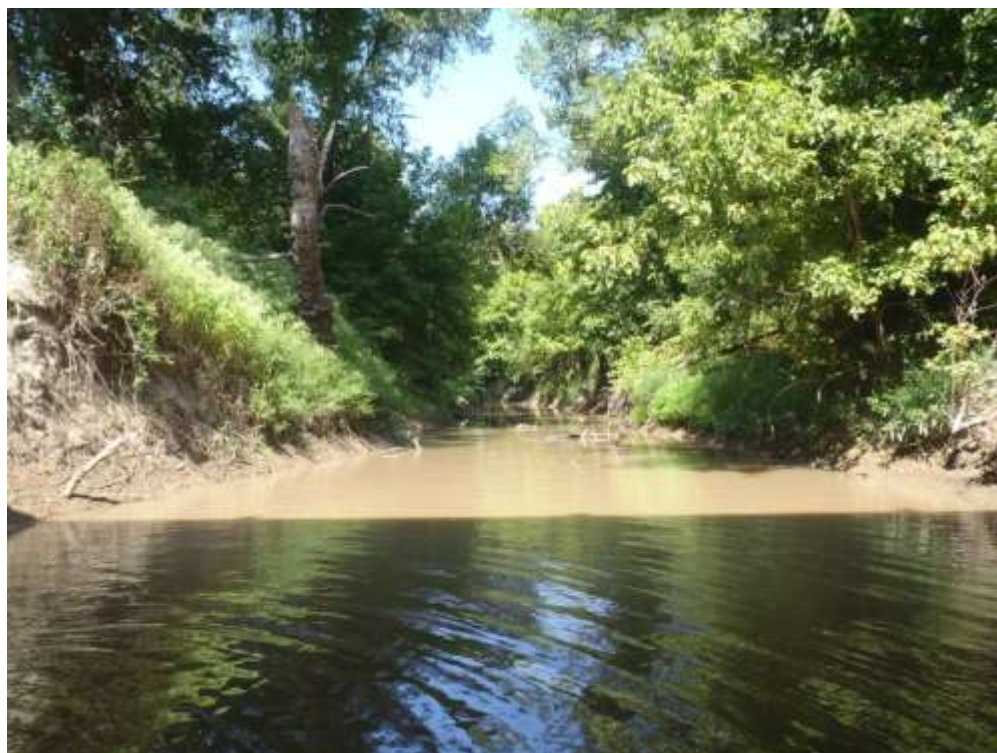
**Figure 4.86** Photograph of White Oak Creek Site WH39 taken on August 7, 2016. Upstream view of the 150-m transect.

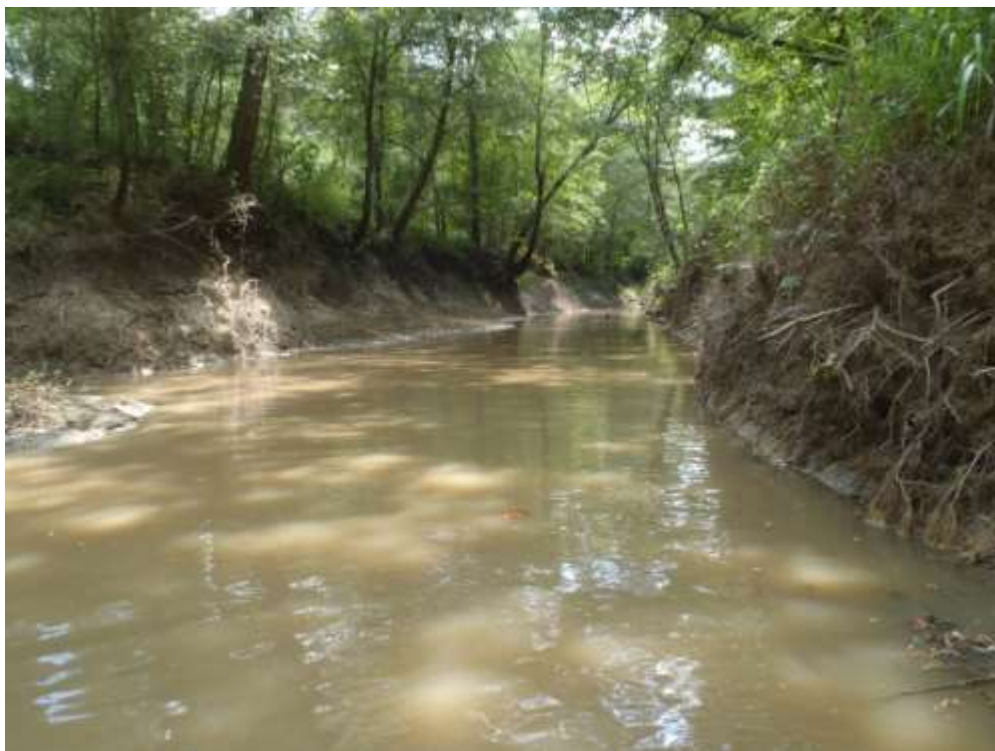
**Figure 4.87** Photograph of White Oak Creek Site WH40 taken on July 22, 2016. Upstream view of the 0-m transect.

Similar to WH39, the stream at WH40 also passed through thick native, forest vegetation with a large riparian area (Table 4.5). While some depths allowed for wading, non-wadeable depths were encountered during both surveys. Because banks were steep with thick vegetation, TIAER personnel used a 10-foot aluminum boat with a 5-hp motor to complete the surveys. Average thalweg depths 0.9 m for both surveys, and the stream flow type was characterized as intermittent (Table 4.6). Channel widths of the creek ranged from 4 m to 16 m during the first survey and 4 m to 17 m during the second survey. The typical average width remained 11 m during both surveys (Tables 4.7 and 4.8). Figure 4.87 illustrates a typical representation of this site, while Figure 3.88 illustrates the narrowest portion of the channel at this site, approximately 4 m wide.

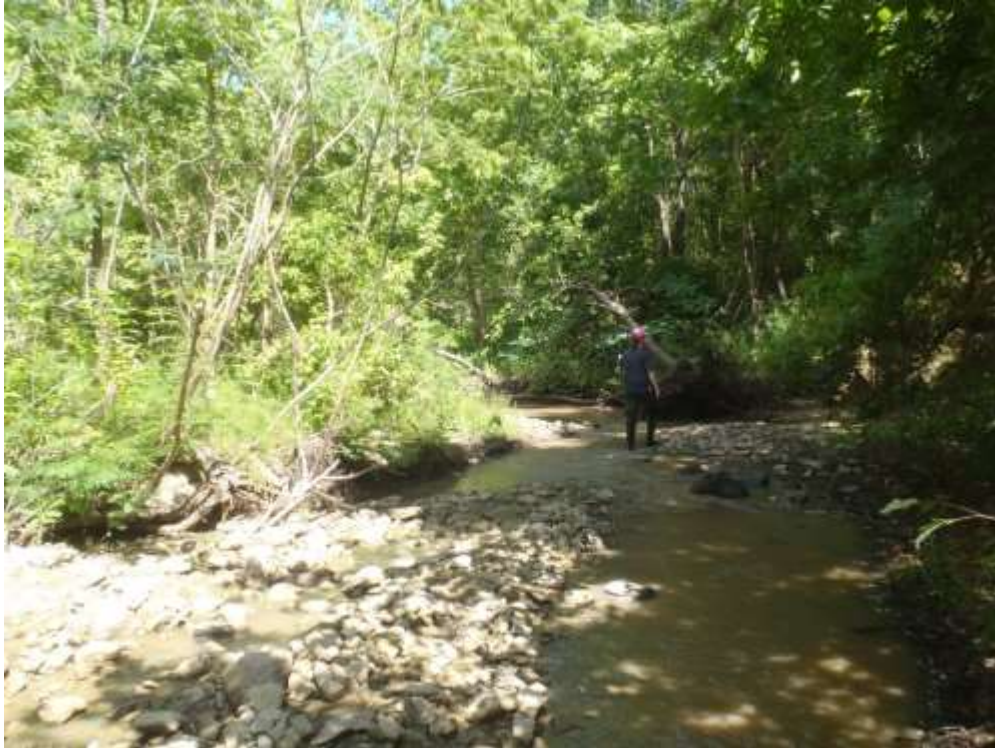
**Figure 4.89** Photograph of White Oak Creek Site WH41 taken on July 20, 2016. Downstream view of the 150-m transect. TIAER personnel in photo.

The creek at this site passed through improved pastures with native vegetation. The large riparian area on the right and left banks held trees and native pasture leading directly up to the edge of the stream bank. Unlike other areas along White Oak Creek, banks at this site were not considered steep by TIAER personnel. The dominant substrate of the stream was mud/clay with rip rap and concrete at the 300-m transect where the stream meets with the Lake Sulphur Springs dam (Table 4.5). The general appearance of the creek at this site is shown in Figures 4.89 and 4.90.

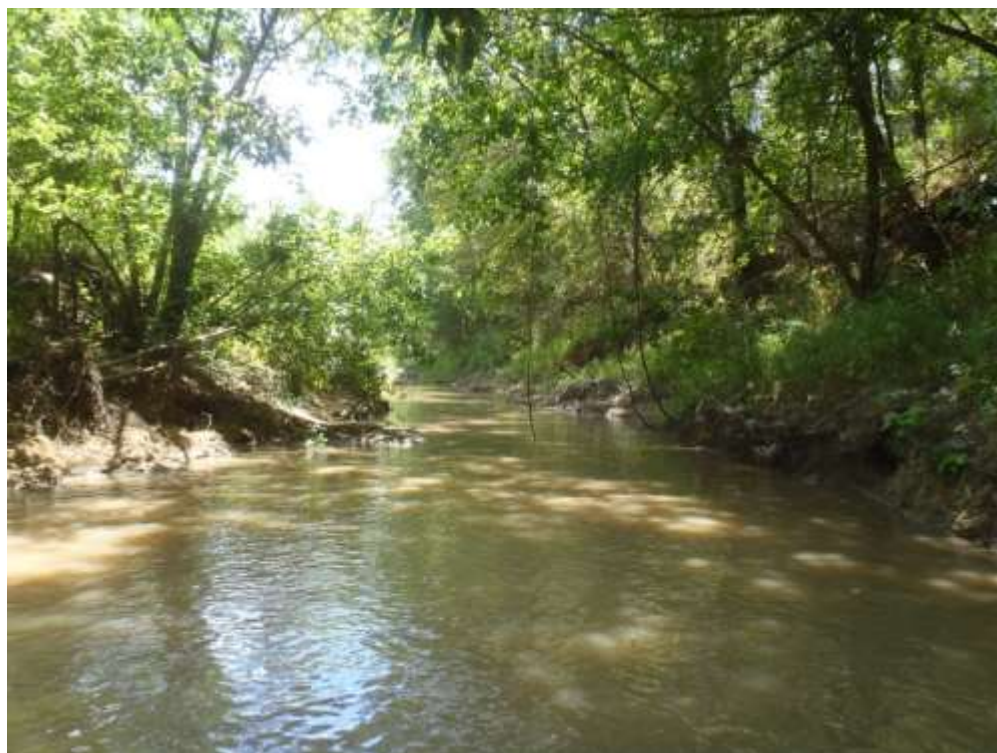
**Figure 4.90** Photograph of White Oak Creek Site WH41 taken on August 8, 2016. Downstream view of the 0-m transect.
